ASIA **TURBOMACHINERY & PUMP** SYMPOSIUM
MARCH 2018 | SUNTEC | SINGAPORE

Emerging Failures in Gas Turbine Engines Operating in Hot Environments

Two (2) gas turbine engines operating offshore experienced Domestic Object Damage (DOD) failure with damaged blades in the HP compressor section.

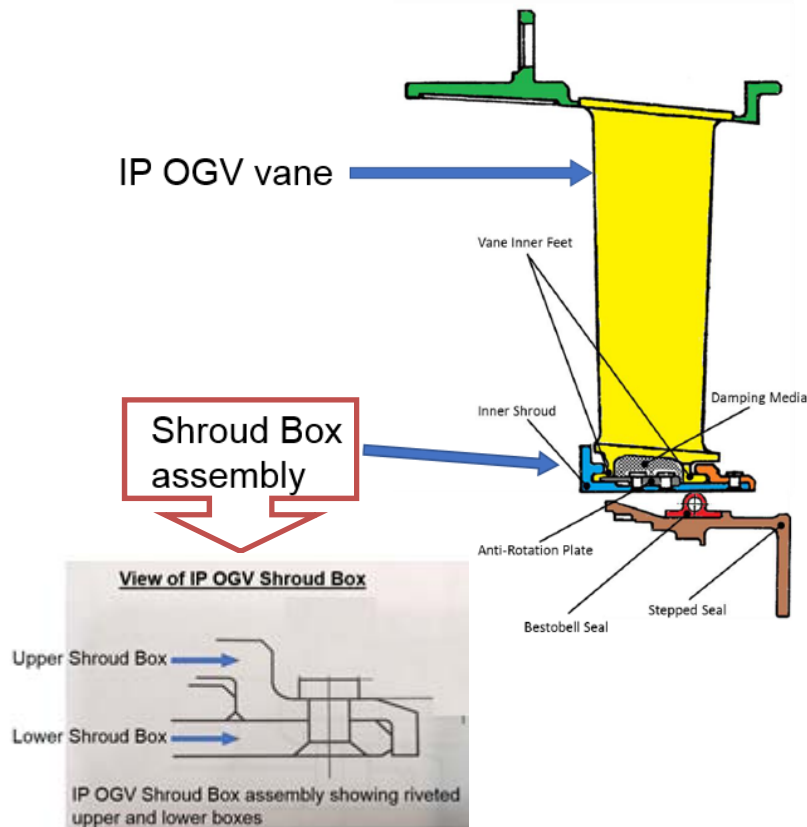
Fig 2: View of Shroud Box & IP OGV Assembly

The current solution to prevent failures is to replace the component during engine overhaul. The component is the shroud box which holds the 7th Stage Outlet Guide Vane (OGV) of the engine's IP compressor section.

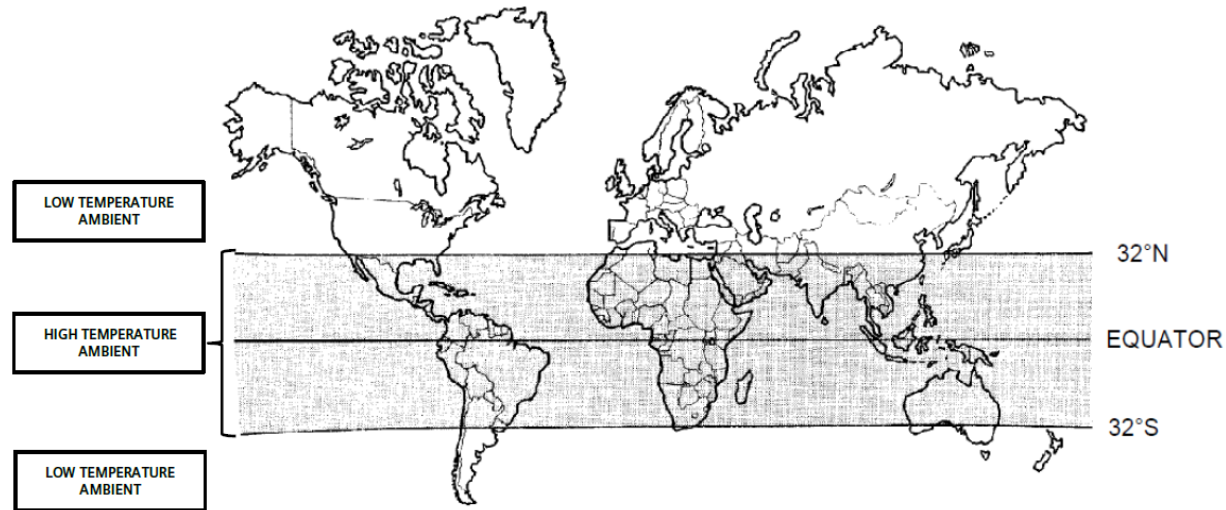
Fig 7: Definition of HIGH / LOW temperature ambient

- Even in this high ambient environment, we have had good fleet reliability, often exceeding OEM overhaul recommendation
- To maintain high reliability, OEM was actively involved to investigate the root cause and implement the solution
